OHIO RIVER BASIN  
COVE RUN, SOMERSET COUNTY  
PENNSYLVANIA  
DEER VALLEY LAKE DAM

NDS I.D. No. PA - 00230  
PENNDER I.D. No. 56 - 76

PHASE I INSPECTION REPORT  
NATIONAL DAM INSPECTION PROGRAM

AUGUST 1979

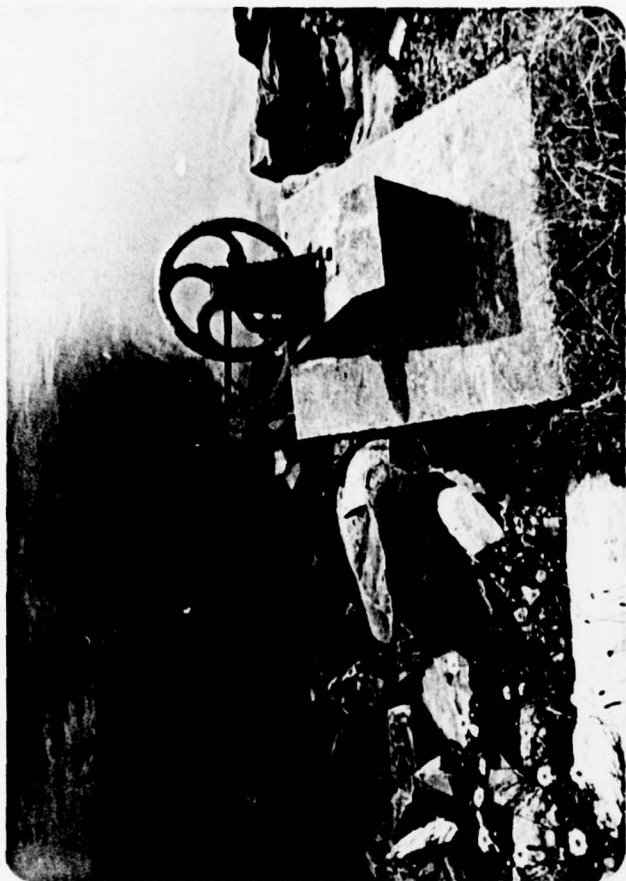
6

There are no formal maintenance procedures in effect for the spillway system or drawdown facility. The slide gate on the drawdown pipe has not been operated for years. The observed condition of the gate stem (see Photograph 6) indicates that it may be inoperable.

d. Have the drawdown mechanism inspected to assess the condition of the slide gate and control rod and take remedial measures to restore the operability of the system.

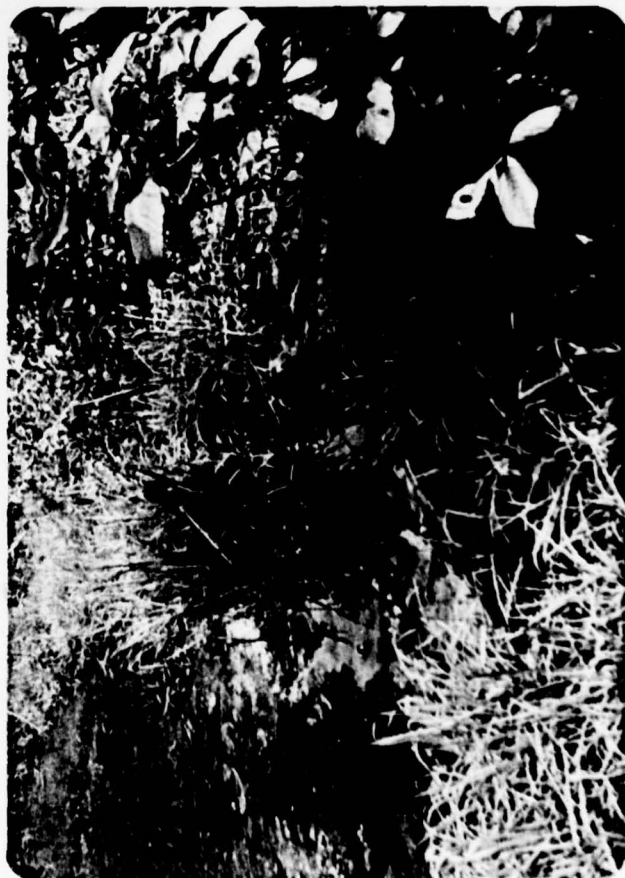
PHOTOGRAPH 7 Close-up view of the partially submerged discharge end of the outlet conduit located at the downstream embankment toe.
